Comer Inspection Services, Inc.

HOME INSPECTION REPORT

Joe Florida
1000 Anywhere St
Anywhere, Fl 32000

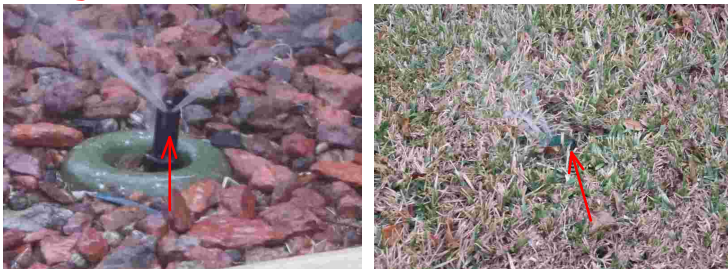
2. Lawn Sprinklers: Front, sides, back----- The sprinkler system appeared to have 5 zones connected at the control panel however, only 4 zones were working. There were damaged heads in zone 1, near the back Lanai screen door, and in zone 3, on the right property line. Zone 3 did not appear to have full pressure, as one of the rotor heads would not pop up. Repairs are recommended by a qualified irrigation technician.

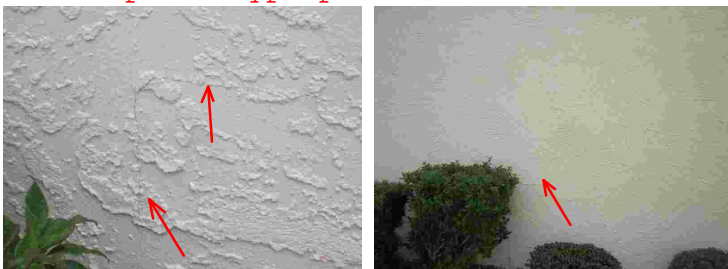
3. All sides Exterior Surface Type: Stucco----- Common cracks and step cracking in the stucco siding on the, left side, between A/C unit and glass block for master bathroom. These types of cracks are caused by the mortar on the concrete blocks "shrinking" when it dries, causing it to pull away from one side of the block, in turn causing small cracks in the stucco siding. These cracks can allow moisture inside the blocks. These cracks should be filled with caulk and painted with a weatherproof type paint / sealer.

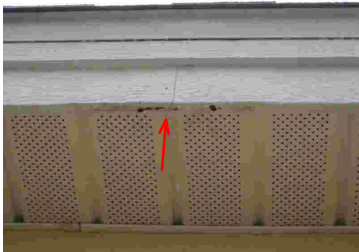
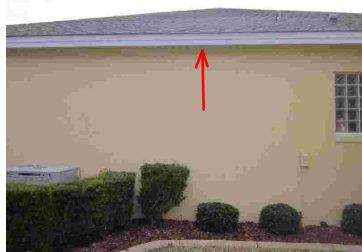
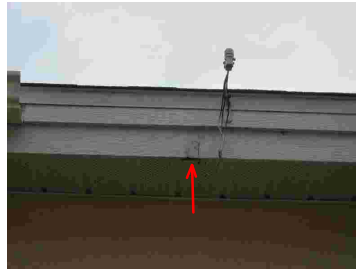
4. Fascia: Wood---- Wood rot on left side approximately 8' in front of exterior A/C unit, below rain sensor on left side of garage, and left front corner of garage.

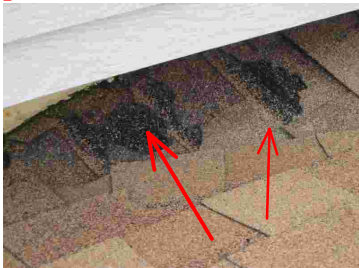
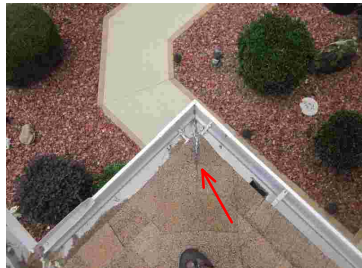
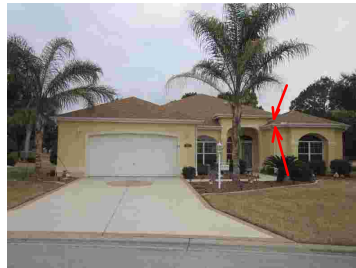
5. Main Roof Surface Material: Dimensional, Asphalt fiberglass shingles---- Damaged shingles noted under the front right side of the front entry roof area, and on the front right corner above the sidewalk.

Loss of granules is minor in most places. Roof shows signs of normal deterioration / wear. Normal life expectancy for this type of roof is 15 to 17 years .

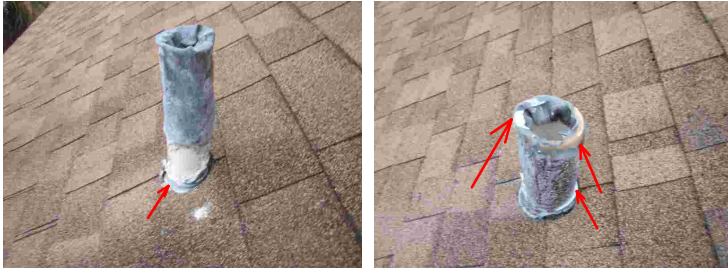
6. Plumbing Vents: PVC with lead jacket flashing---- Plumbing vents have had poor repairs done in the past. The caulk around the area is showing signs of deterioration, which could lead to leaks. We recommend replacing vent flashing or installing new composite "Squirrel proof" covers over the current vents.

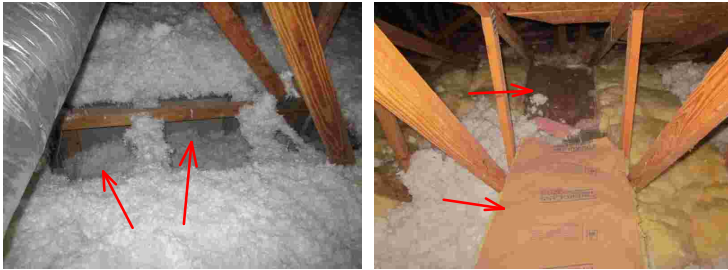
7. . Attic Insulation: Batts, blown in fiberglass---- 1. Blown in insulation above the hall closet cavity has settled, allowing vertical wall space to be unprotected. We recommend installing 1 or 2 pieces of "batt" style insulation over the opening to compensate for settled insulation.
2. Batt style insulation has been installed with the paper side exposed above the living room area. (just a couple of pieces). This is a fire hazard per the manufacture. We recommend turning those pieces over.

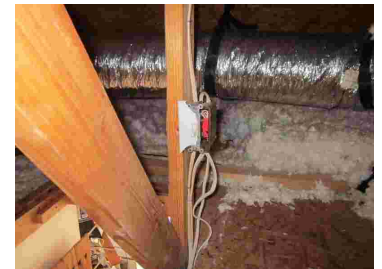
8. . Attic Wiring/Lighting: 120 VAC lighting circuit---- Damaged switch plate on light switch in attic. Recommend replacing to prevent future shock hazard.

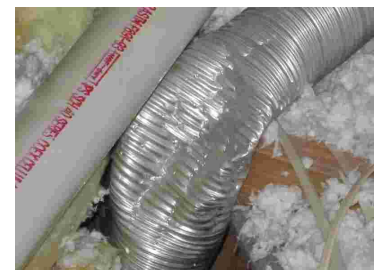
9. . Attic Bathroom Fan Venting: Electric fan---- Fans were vented soffit vents. Vent pipe above the master bathroom has been crushed, restricting air flow. Repairs are recommended

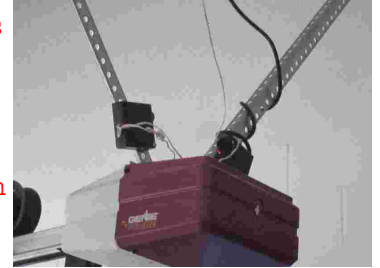
10. Front entry Garage Door Opener: Genie---- The electronic sensors for the screen door have been improperly installed. Currently the sensors are located above the door opener. This is a potential life / safety hazard that could result in serious injuries or even death. The manufacture installation instructions are very specific about the installation location of the sensors. Most manufactures require the sensors to have a final mounting position 4" to 6" above floor level. Any deviation from the installation instructions will void all warranties. It is recommended that the sensors be installed per the manufacture installation requirements before Close of Escrow. Only a qualified garage door professional should complete the installation.

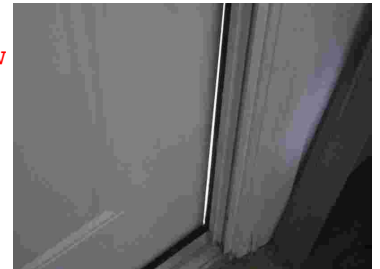
11. Front entry Garage Service Doors: Metal 6 panel ---- Weatherstripping on door to exterior has a gap that will allow water to penetrate below the handle to the floor.

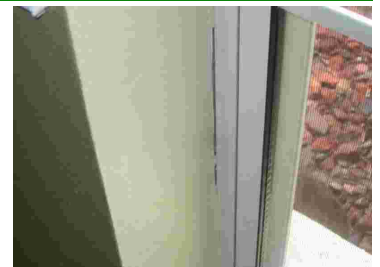
13. Living room, Dining room, Hall, Breakfast nook Living Space Windows: Single Hung double Pane---- Caulk needed on front inside window frame on window in breakfast nook.

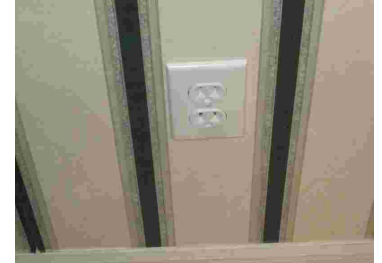
14. Master Bathroom Electrical: 120 VAC 3 prong grounded outlets, 120 Volt GFCI outlets---- **Open or missing ground on out in water closet (toilet room).**

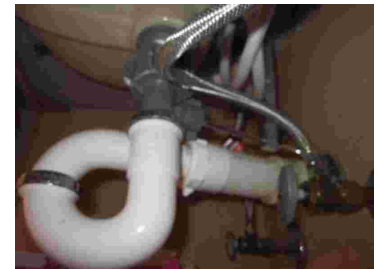
15. Master Bathroom Faucets/Traps: Double handle faucet, Delta fixtures with a PVC trap---- **Leak noted at drain stopper lock nut under sink in drain pipe on left sink. Repairs are recommended**

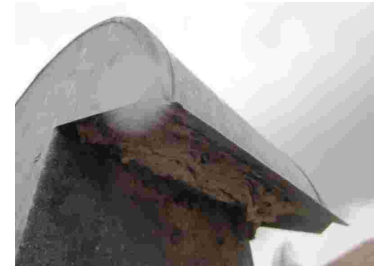
18. Utility room Laundry Room/Area Dryer Vent: Foil flex and rigid metal---- **The dryer vent pipe on the roof is either partially or fully restricted with dryer lint. This poses a safety / fire hazard and / or a potential opportunity to damage the dryer element or heating component. Recommend having vent cap and vent pipes cleaned to prevent future safety hazard. Photo shows current condition of outlet.**

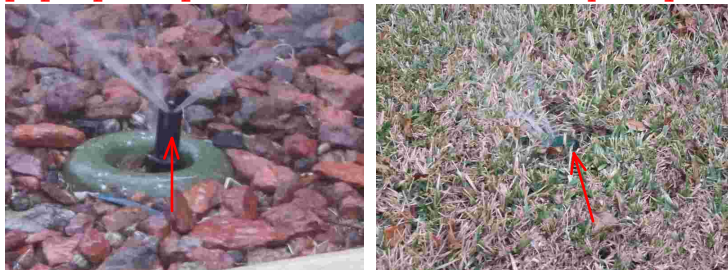
7. Lawn Sprinklers: Front, sides, back---- The sprinkler system appeared to have 5 zones connected at the control panel however, only 4 zones were working. There were damaged heads in zone 1, near the back Lanai screen door, and in zone 3, on the right property line. Zone 3 did not appear to have full pressure, as one of the rotor heads would not pop up. Repairs are recommended by a qualified irrigation technician.

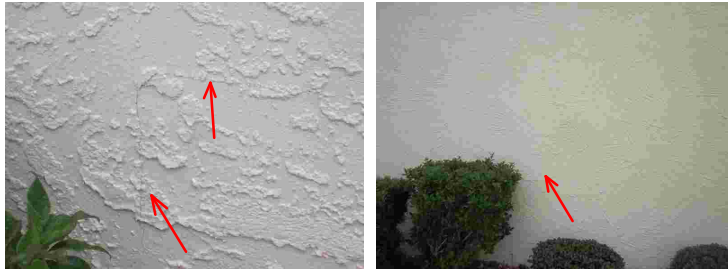
1. Type: Stucco----- Common cracks and step cracking in the stucco siding on the, left side, between A/C unit and glass block for master bathroom. These types of cracks are caused by the mortar on the concrete blocks "shrinking" when it dries, causing it to pull away from one side of the block, in turn causing small cracks in the stucco siding. These cracks can allow moisture inside the blocks. These cracks should be filled with caulk and painted with a weatherproof type paint / sealer.

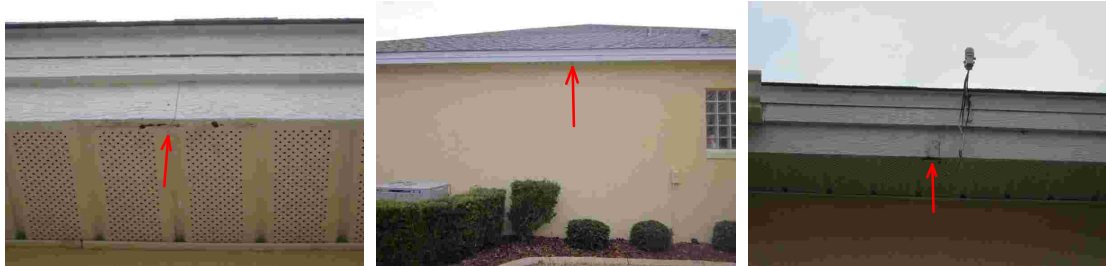
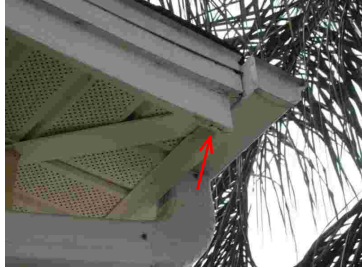
3. Fascia: Wood----- Wood rot on left side approximately 8' in front of exterior A/C unit, below rain sensor on left side of garage, and left front corner of garage.

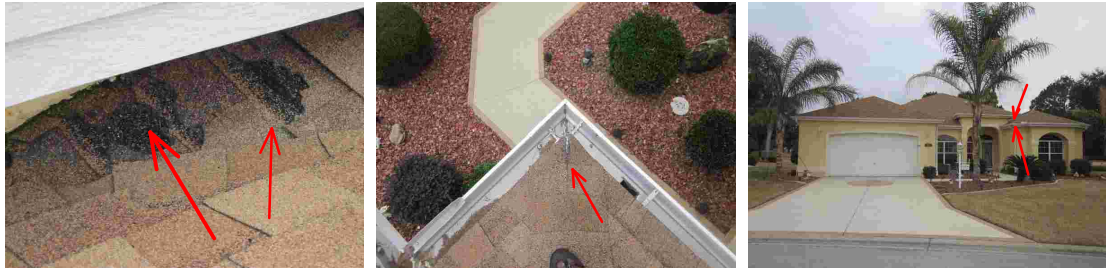
1. Method of Inspection: Walked most of roof
2. Unable to Inspect: 0%
3. Material: Dimensional, Asphalt fiberglass shingles---- **Damaged shingles noted under the front right side of the front entry roof area, and on the front right corner above the sidewalk.**

Loss of granules is minor in most places. Roof shows signs of normal deterioration / wear. Normal life expectancy for this type of roof is 15 to 17 years .

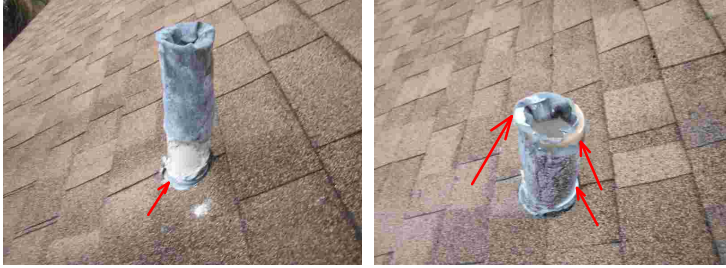
4. Type: Hip
5. Approximate Age: 1997
6. Flashing: Aluminum and galvanized flashing
7. Valleys: Asphalt shingle
8. Plumbing Vents: PVC with lead jacket flashing---- **Plumbing vents have had poor repairs done in the past. The caulk around the area is showing signs of deterioration, which could lead to leaks. We recommend replacing vent flashing or installing new composite "Squirrel proof" covers over the current vents.**

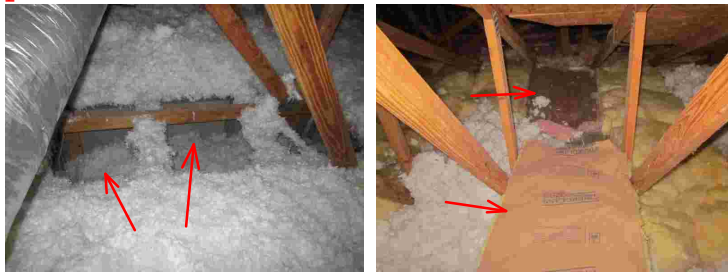
4. Sheathing: OSB, strand board
5. Truss Tie Downs: Single wrapped galvanized straps
6. Ventilation: Ridge, below ridge and soffit venting
7. Insulation: Batts, blown in fiberglass---- 1. Blown in insulation above the hall closet cavity has settled, allowing vertical wall space to be unprotected. We recommend installing 1 or 2 pieces of "batt" style insulation over the opening to compensate for settled insulation. 2. Batt style insulation has been installed with the paper side exposed above the living room area. (just a couple of pieces). This is a fire hazard per the manufacture. We recommend turning those pieces over.

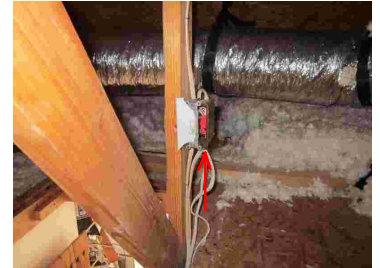
9. Wiring/Lighting: 120 VAC lighting circuit----
Damaged switch plate on light switch in attic.
Recommend replacing to prevent future shock hazard.

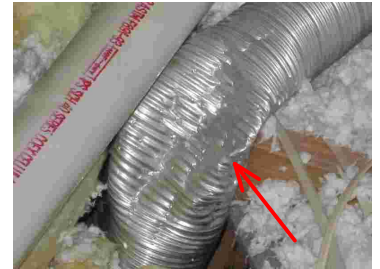
10. Moisture Penetration: None noted
11. Bathroom Fan Venting: Electric fan---- Fans were
vented soffit vents. Vent pipe above the master
bathroom has been crushed, restricting air flow.
Repairs are recommended

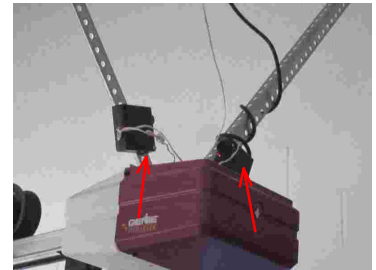
The electronic sensors for the screen door have been improperly installed. Currently the sensors are located above the door opener. This is a potential life / safety hazard that could result in serious injuries or even death. The manufacture installation instructions are very specific about the installation location of the sensors. Most manufactures require the sensors to have a final mounting position 4" to 6" above floor level. Any deviation from the installation instructions will void all warranties. It is recommended that the sensors be installed per the manufacture installation requirements before Close of Escrow. Only a qualified garage door professional should complete the installation.

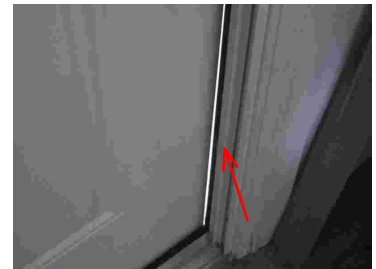
Weatherstripping on door to exterior has a gap that will allow water to penetrate below the handle to the floor.

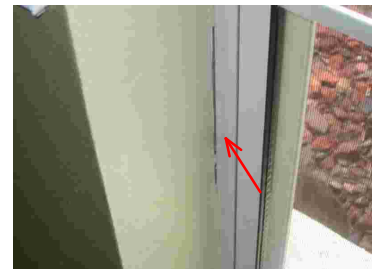
| 6. | <input type="checkbox"/> | <input type="checkbox"/> | <input checked="" type="checkbox"/> | <input type="checkbox"/> | <input type="checkbox"/> | Windows: Single Hung double Pane--- Caulk needed on front inside window frame on window in breakfast nook. |

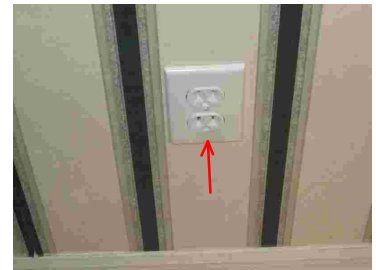
| 6. | <input type="checkbox"/> | <input type="checkbox"/> | <input checked="" type="checkbox"/> | <input type="checkbox"/> | <input type="checkbox"/> | Electrical: 120 VAC 3 prong grounded outlets, 120 Volt GFCI outlets--- Open or missing ground on out in water closet (toilet room). |

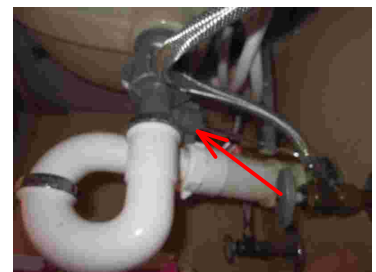
| 9. | <input type="checkbox"/> | <input type="checkbox"/> | <input checked="" type="checkbox"/> | <input type="checkbox"/> | <input type="checkbox"/> | Faucets/Traps: Double handle faucet, Delta fixtures with a PVC trap--- Leak noted at drain stopper lock nut under sink in drain pipe on left sink. Repairs are recommended |

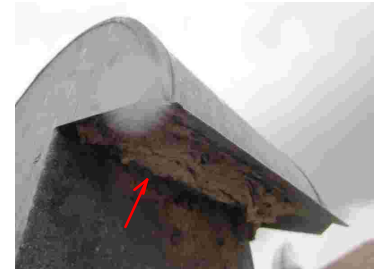
| 11. | <input type="checkbox"/> | <input type="checkbox"/> | <input checked="" type="checkbox"/> | <input type="checkbox"/> | <input type="checkbox"/> | Dryer Vent: Foil flex and rigid metal--- The dryer vent pipe on the roof is either partially or fully restricted with dryer lent. This poses a safety / fire hazard and / or a potential opportunity to damage the dryer element or heating component. Recommend having vent cap and vent pipes cleaned to prevent future safety hazard.

Photo shows current condition of outlet. |
